Appendix F2 – Assessment of Controls (Stormwater Management Assessment)

Wexford 2016 Annual Physical Assessment

Harford County Department
of Public Works

December 2016

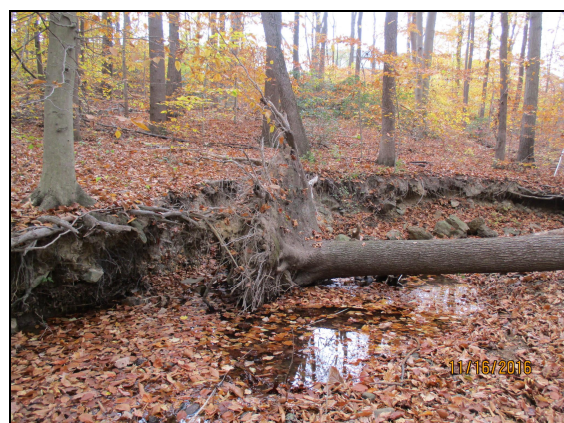
The profile and cross section data collected for 2016 were superimposed over the data collected for years 2012 to 2015. The 2016 profile data generally shows a slight trend of channel thalweg incision and pool deepening, especially in the lower 1,200 linear feet. The channel appears unable to transport the sediment load, which results in large mid-channel and lateral bar formation. These depositional features, comprised of cobble size material, increase near bank shear stresses that result in erosion of the bank and bed. Downed trees and large wood debris have also caused local bed and bank erosion at several locations. Several large trees were observed to have fallen in the stream channel between the 2015 and 2016 surveys. Specific examples can be seen in the photographs below.

2016 Survey: STA 8+10, looking upstream

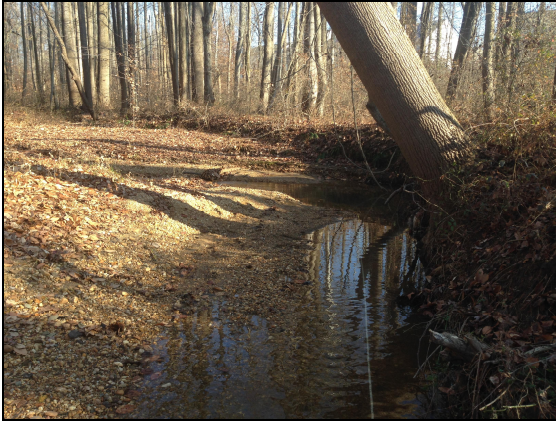
2015 Survey: STA 20+00, looking upstream

Notable changes in the channel bed include from station 18+00 to 24+00, where the channel appears to be downcutting and pools have deepened. Scour pools due to log jams are present at station 12+90 and 14+40. Throughout the reach, large lateral and mid-channel bars, comprised of loose sand and gravel overwhelm the channel and are frequently shifted by storm flows. This is most obvious in the lower half of the reach, as the thalweg has shifted as a result of mobilization of the sand and gravel bars. The stream banks and bed in the vicinity of the sewer encasement at station 23+90 continue to degrade, the area should be monitored closely.
